# Some considerations on the failure of Güney Waterfall, Denizli, Turkey

## H. Kumsar

ABSTRACT: The Güney Waterfall in Denizli was ruptured by the The 21<sup>st</sup> July 2003 Buldan earthquake with magnitude 5.6. The ruptured block toppled after 10 years and traveled towards the reservoir of Cindere Dam more than 132 m. The authors attempt to clarify the mechanism and process of the toppling failure of the ruptured block. The authors attempt to analyse the failure process in fundamentally in three stages. The first stage is the initial failure caused by the earthquake. The second stage is the growth of the ruptured block and progress of degradation at the toe of the failed block. Third stage is the final collapse and movement in the valley towards the Cindere Dam reservoir. The pre-rupture stage before the Buldan earthquake and post-rupture and final collapse conditions are analysed through some analytical and numerical techniques to understand the fundamental causes of the failure, which took more than 10 years. This is study is unique in a sense it involves slow and rapid dynamic processes. The authors present the results of the various studies and investigations undertaken s

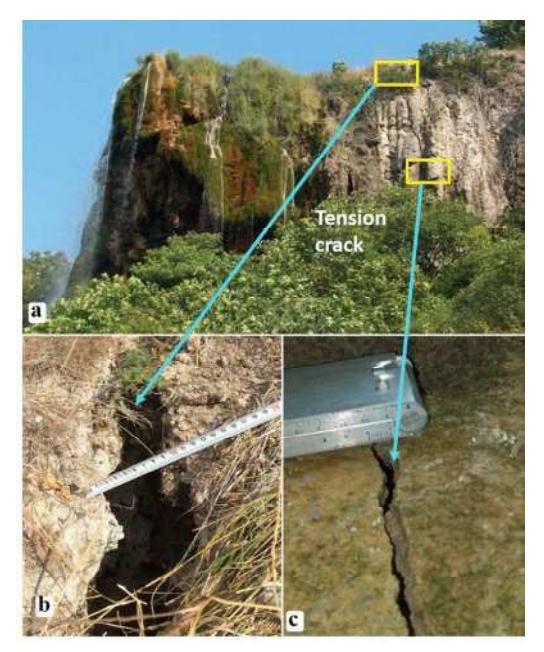
The seismic activity in Buldan and surrounding in Denizli basin started with a 5.2 magnitude at 07:56 AM on 23<sup>rd</sup> of July 2003. Another earthquake with a magnitude of 5.6 occurred at 11:26 AM on 26<sup>th</sup> July 2003 (Fig. 2). The last shock caused damages on masonry structures, slopes failures and tension cracks on roads and slopes (Kumsar et al, 2003). Güney waterfall, which is located at about 15 km east the earthquake epicenter location, was also ruptured due to 5.6M earthquake. 13 cm wide tension crack developed at 8 m back side from the outer most of the of the waterfall tufa head (Fig. 3), and this crack continued to the base of the tufa (Kumsar et al., 2008). An illustration, showing rupture of tufa block, is given in Fig. 4a. After the earthquake, some part of spring water flowed through the cracks

Figure 3. a) Overhanging tufa block of Güney waterfall, b, c) tension cracks developed during 2003 Buldan earthquake with a magnitude of 5.6 (Kumsar et al, 2008).

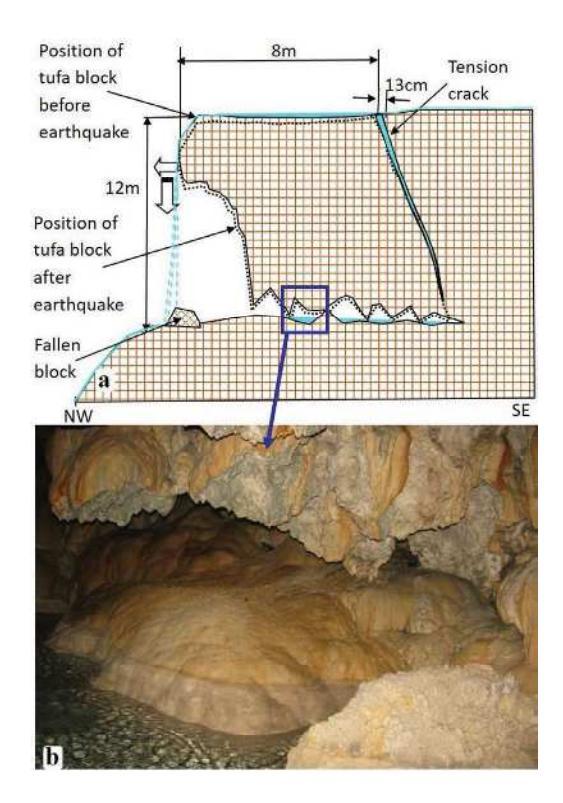
and, the caves within the tufa block were filled up with water (Fig. 4b). The maximum ground acceleration caused by the earthquake at the waterfall site was estimated to be more than 120 gals.

Figure 4. a) Schematic drawing of tension crack development within the tufa block of Güney waterfall, b) view from a cave within the tufa block.

The height and length of the overhanging part were measured to be 10 m and 8 m, respectively in view of site observations and investigations as shown in Fig. 4(a). Under gravitational conditions with a unit weight of 20 kN/m<sup>3</sup> for rock mass, the maximum tensile stress at the top of the overhanging waterfall tufa would be 384 kPa.

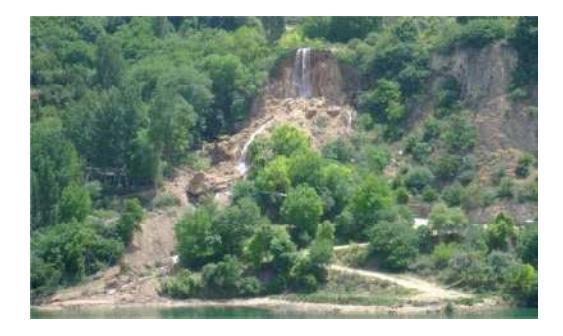
The tufa block stayed stable for about 10 years. A big block from the most outer part of the tufa block that had been overhanging for more than 10 years, toppled on 13.05.2013 (Kumsar et al, 2013). The unstable tufa block was broken into many parts and partly moved into Cindere Dam reservoir (Fig. 5).

Figure 5. A view of the collapsed waterfall tufa and disintegration from the Cindere Dam reservoir.

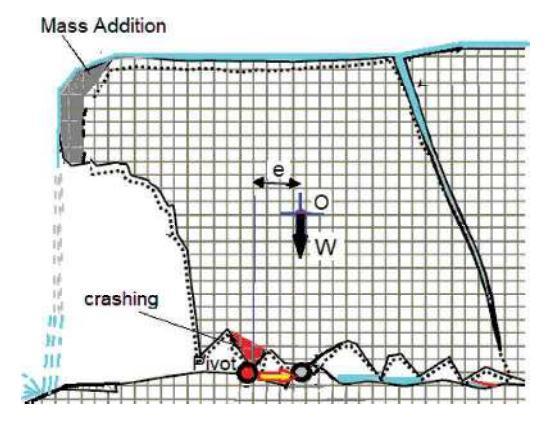
Figure 11. An illustration of the mechanism leading to the toppling of the fallen tufa block.

degradation and crashing of the tufa at the protruding parts. As a result of this process, the pivot of the fallen tufa block against rotation should have started in space. Furthermore, the mass addition to the already fallen tufa block due to the sedimentation from water flow having dissolved Ca–HCO<sub>3</sub> content would occur. These two processes should had prepared the conditions suitable for toppling failure of the fallen block after a period of 10 years. This situation is conceptually illustrated in Fig.11. The horizontal rate of the movement of the pivot in the space has been estimated to be about 20 mm/ year. Furthermore, the mass addition of 10 cm thick and 3-4 m high would had been taken place. This is a slow dynamic process taking place in years.

The block would stay almost in the same position until the horizontal location of the pivot is becomes beyond the horizontal position of the fallen block provided that the vertical position of the mass center does not change with time. Once the location of the pivot becomes beyond the horizontal location of the mass center, the fallen block would start to topple and it would be a very rapid dynamic process. Until the blocks hits the ground, the process is quite simple and it can be easily evaluated as a rigid body motion. However, the process would become quite complicated if the block starts to disintegrate after hitting the ground and/or fracturing during motion in space. Fig. 12 shows the computed rotation angle and horizontal displacement responses of the block shown in Fig. 11. As it is noted from the figure, the toppling rapidly occurs within 45 seconds while the preparation of the fallen block to topple took more than 10 years.
