## Some considerations on the stability and design of underground structures during earthquakes

**ABSTRACT:** In Japan, many underground structures have been constructed and are in service in spite of complex and poor geological conditions. On the other hand, Japan is famous for big earthquakes resulting a huge national loss, thus the seismic design is very important for every kind of structures. However, the seismic design of underground structures, especially mountain tunnel, has not been well discussed up to now, while mountain tunnels were also severely damaged in the recent earthquakes. Therefore, the seismic design for the underground structures should be discussed as an important and urgent problem.

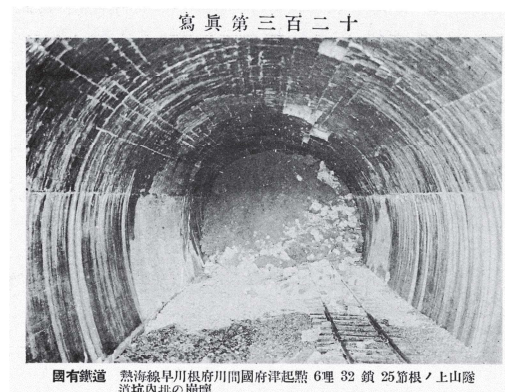
Photo 2. Damage of mountain tunnel by Kanto Earthquake in 1923 (from Digital archive of Japan Society of Civil Engineers, [http://library.jsce.or.jp/Image\\_DB/shin-sai/kanto/jsce\\_report/jsccrp\\_02\\_04.html](http://library.jsce.or.jp/Image_DB/shin-sai/kanto/jsce_report/jsccrp_02_04.html)).

Photo 2 shows an example of tunnel damage, where a large scale collapse of tunnel crown occurred.

In the Kanto Earthquake, 93 tunnels out of the 149 tunnels (including under construction) of national railway was damaged and repair was done. Those tunnels was within the range of about 120 km from the epicenter. The severe damage can be seen in seven tunnels out of 11 tunnels located between Odawara and Manazuru of Atami line (present Tokaido Line). Landslides and slope failures caused collapse and burial near the portals, and cracks and cross sectional deformation occurred even in locations away from the entrance.

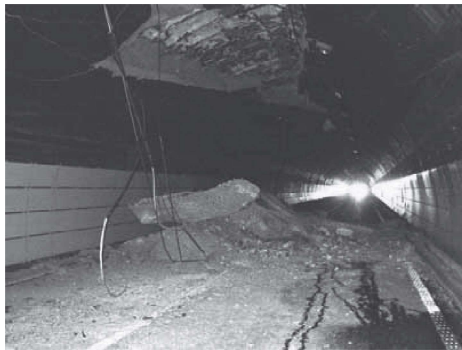
Photo 3 shows a damage of road tunnel, where the concrete lining was fallen down from the crown.

However as the result of the detailed survey, it was judged that large repair was not necessary and restoration with installation of steel rib and shotcrete could be carried out without closing the road. As seen in this damage picture, the rock behind tunnel lining did not collapsed and is stable state although the concrete lining collapsed.

Photo 3. Damage of rock tunnel by Chuetsu Earthquake in 2004 (provided by MLIT Hokuriku Regional Development Bureau).

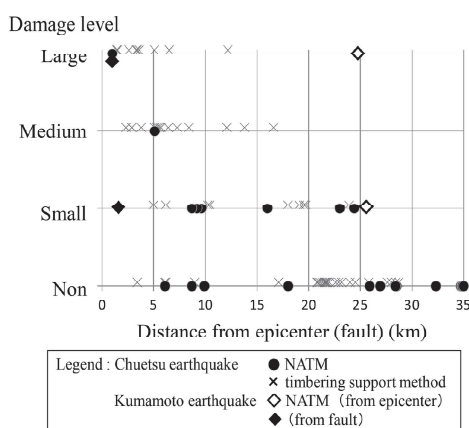
Figure 3 shows the relationship between the construction method of these tunnels and the level of damage and the distance from the epicenter. In the tunnel by the steel-sets with timber lagging construction method, large and medium damage has occurred even if it is 10 km or more away from the epicenter. On the other hand, tunnels by NATM are only heavily damaged within the distance of 5 km. A big difference in earthquake resistance between tunnels of the steel-sets with timber lagging construction method and NATM tunnels is obvious.

Figure 3. Relationship between damage level and distance from epicenter (fault).

From the three damage forms shown in 2.4 and the results in Figure 3, the relationship between the earthquake damage of the rock tunnel and
