Dynamic response and stability of some historical masonry structures subjected to ground shaking

ABSTRACT: Historical structures are mainly masonry structures, which are composed of blocks made of natural stones, bricks or both, and they are assembled in different patterns with or without mortar. The authors have been recently involved with the restoration of the famous Shuri Castle, Nakagusuku Castle, Gushikawa Castle, an arch bridge in Iedonchi Royal garden and Yodore Royal Mausoleum of the Ryukyu Imperial period as well as static and dynamic stability assessment of some natural rock structures such as Perry Banner Rock. The deterioration by atmospheric agents, bombing and seismic shaking damaged some of these structures. The recent earthquakes in Kumamoto also caused severe damage to historical masonry structures. The authors describes the outcomes of experimental, limiting equilibrium and numerical studies on the stability of historical masonry structures under dynamic loads such as those induced by earthquakes and their implications are discussed.

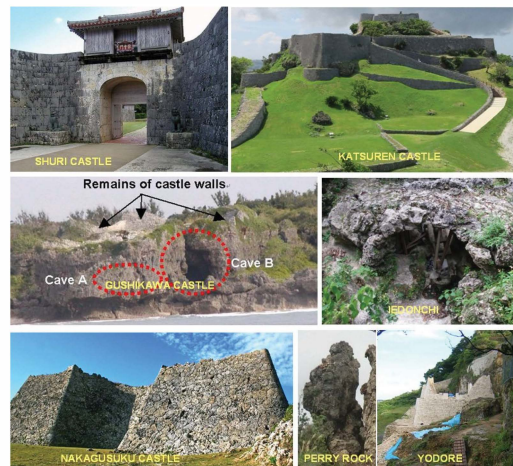
Figure 1. Some of historical masonry structures in Okinawa Island.

Historical structures are mainly masonry structures, and they are composed of blocks made of natural stones, bricks or both, and they are built in different patterns with or without mortar. The authors have been recently involved with the restoration of the famous historical structure in Okinawa Island such as Shuri Castle, Nakagusuku Castle, Gushikawa Castle, an arch bridge in Iedonchi royal garden and Yodore royal mausoleum of the Ryukyu Imperial period, as well as the assessment of static and dynamic stability of some natural rock structures such as Perry Banner Rock (Figure 1).

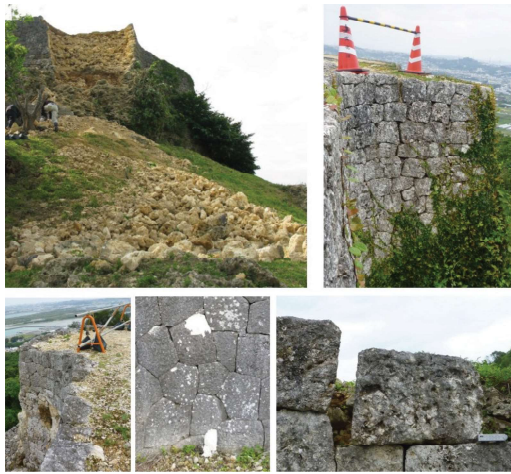
Figure 2. Damage induced by 2010 Off-Okinawa earthquake on Katsuren Castle.

As Japan is a seismically active country, an emphasis was given on the seismic response and stability of restored masonry structures such as arches and walls during earthquakes and natural rock structures (Figure 2). Furthermore, the deterioration by atmospheric agents, bombing and seismic shaking damaged some of these structures.

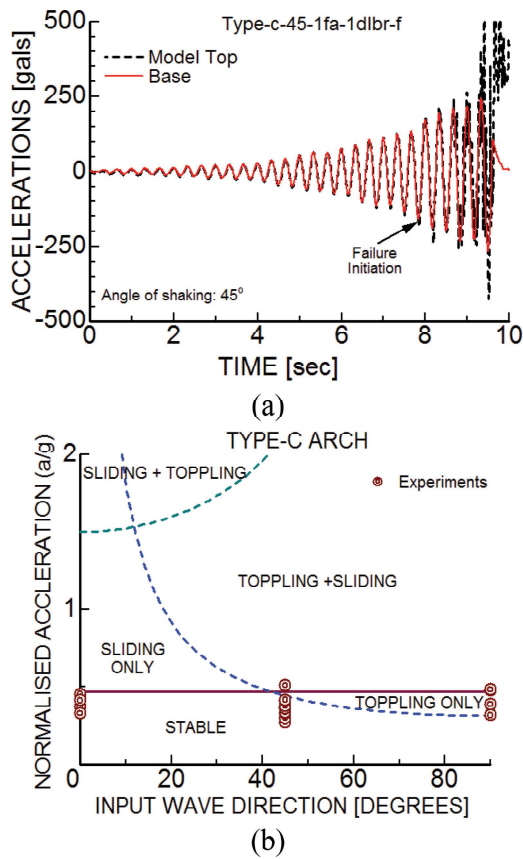
Figure 4. An acceleration record during a model test and stability chart.

cated that the amplitude of acceleration waves to cause failure was the lowest for 90° shaking while it was maximum for 0° shaking (Figure 4b).

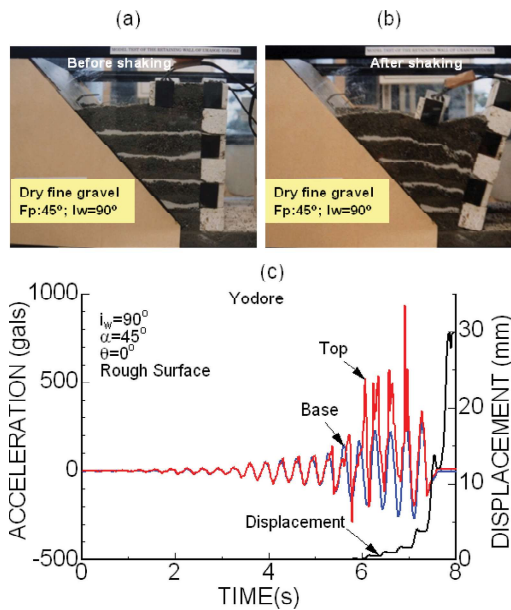
Figure 6. A view of the physical model before and after the shaking.

physical model tests (Figure 6). A physical model of retaining wall with a back filling was constructed. The model was stable under dry condition. When the model was fully saturated and the retaining wall has no drainage holes, it was found that the retaining-wall would fail. Next, the stability of the retaining wall was investigated under dynamic conditions. Figure 6 shows an example of a physical model before and after shaking together with displacement response of the wall. As noted from the figure, the retaining wall starts to exhibit non-linear behavior when the acceleration level is about 100 gals. After each cycle of shaking, the displacement of the wall increases. This deformation mode involves both relative slip and rotation of the wall with respect to its base.

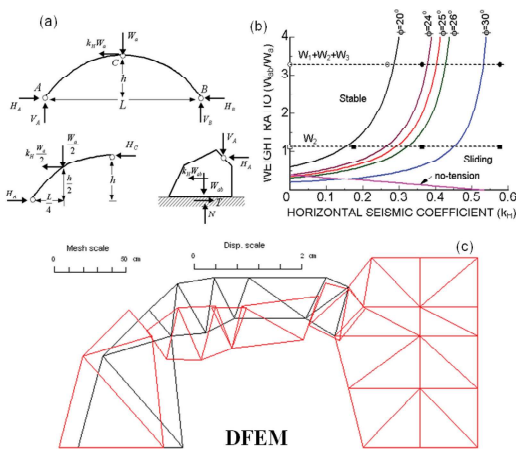
Figure 8. Mechanical model and computed results for PD-LEM and DFEM.

Figure 8a shows a pseudo-dynamic limiting equilibrium method (PD-LEM) for the arch bridge. Figure 8b compares the computational results with measured limiting accelerations to induce failure. Figure 8c shows a computed deformation configuration of the arch bridge using the DFEM.

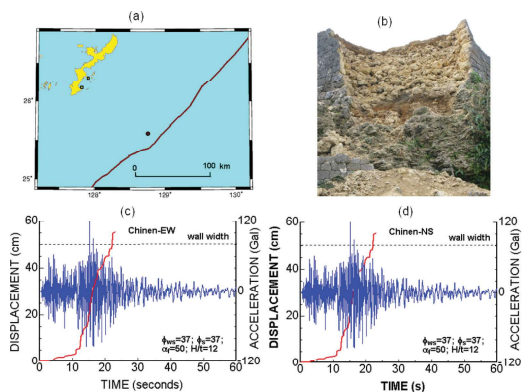
Figure 9. Location of the earthquake, views of the failed wall and computed displacement responses for acceleration records taken at Chinen.

Okinawa Island of Japan (Figure 9a). The focal depth of the quake, which occurred at 5:31 a.m. local time (2031 GMT Friday), was about 40 km under the sea 107 km east off Naha, capital of Okinawa. The collapse of some parts of castle walls at Katsuren Castle, which is designated as a world heritage site, occurred. The castle is located over a hill in Uruma City and the nearest strong motion station of the K-NET strong motion network is Gushikawa. The NW corner of the castle wall with a height of 4m collapsed and there were numerous dislocations and rotation of blocks in the castle as seen in Figure 9b.

The authors carried out a series of analyses using the dynamic limit equilibrium method (D-LEM) and the acceleration records at Chinen and Gushikawa strong motion stations of the K-NET strong motion network. The typical size of the blocks ranges between 50 to 60 cm. The authors used their method (Tokashiki et al. 2007) to back-analyze the collapse of the wall using the strong motion records taken at Gushikawa and Chinen. The wall is stable against toppling mode for strong motions at Gushikawa and Chinen. If the records taken at Gushikawa are used, the relative sliding cannot be greater than 10cm, which implies that the wall should be stable although some slip might take place. However, if the records taken at Chinen are used the relative sliding can be greater than 60 cm for $\theta = 5^\circ$, which exceeds the half size of the block and this implies that the wall should collapse (Figure 9c, d). The bulging of the wall and inclination of the foundation rock strongly supports that this condition would be prevailing at the location of the collapse. As the castle is situated on the top of the hill, it is likely that ground motions might have been amplified also.

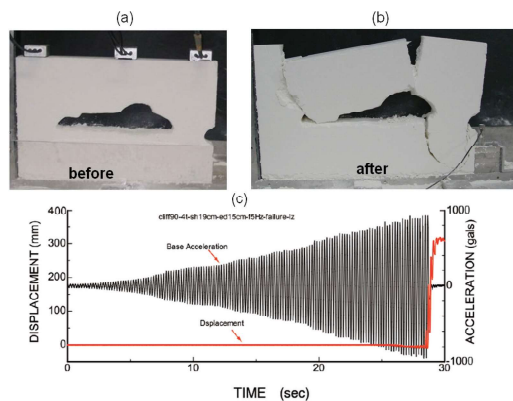
Figure 10. Views of Cave A before and after shaking and the measured response during shaking.

The cavity was first excavated and its deformation to the excavation procedure was monitored. The opening was stable under static condition. Following the frequency response experiments under a base acceleration of 100gals, the model was subjected to horizontal shaking along the longitudinal axis of the cave A until the failure occurred. The frequency of the applied base acceleration was 5Hz and its amplitude was about 600 gals when the model with the cave failed. Figure 10a, b shows a shaking model experiment in relation to the effects of karstic caves beneath Gushikawa castle remains. Figure 10c shows the measured displacement

ment in relation to the applied base acceleration. As noted from the figure, the elastic displacement is very small to be discernible and the displacement becomes very large during the failure stage suddenly.

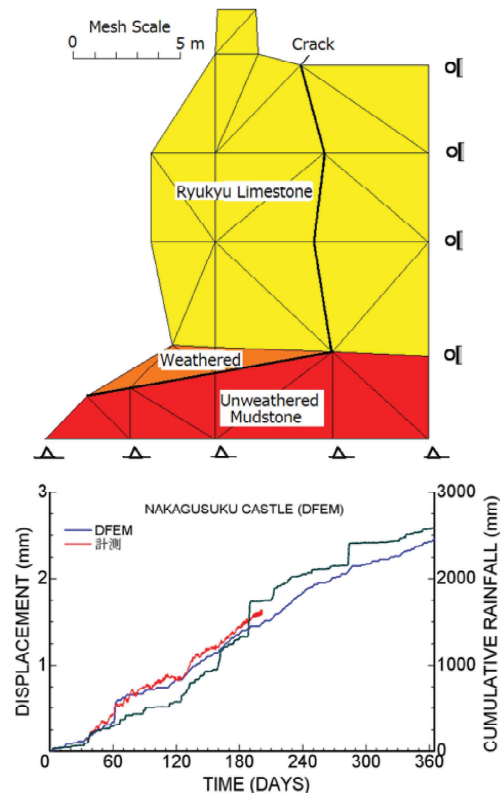
Figure 14. Mesh used DFEM analysis and comparison with measured responses.

A series of analysis using DFEM (Aydan et al. 1996) together with implementation of softening and hardening process of weathered rock mass in relation to rainfall (Aydan 2016) was carried out. Figure 14 shows the mesh used in analyses and comparison of computed results with measurements. The computational model can simulate both permanent displacement induced by the earthquake as well as rainfall induced softening process of weathered rock mass.
