2019 Rock Dynamics Summit– Aydan et al. (eds)
© 2019 Taylor & Francis Group, London, ISBN 978-0-367-34783-3

An experimental study on the formation mechanism of tsunami boulders

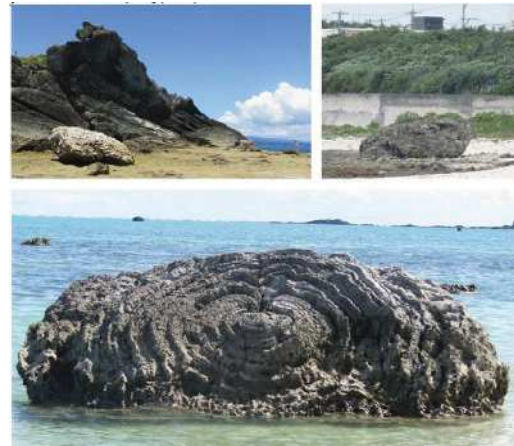
Figure 2. Sea tsunami boulders in Ishigaki Island.

One can also find many boulders on the tsunami-induced boulders, which we call "Sea Tsunami Boulders" (Fig. 2). However, it is extremely difficult to differentiate from the boulders resulting from cliff

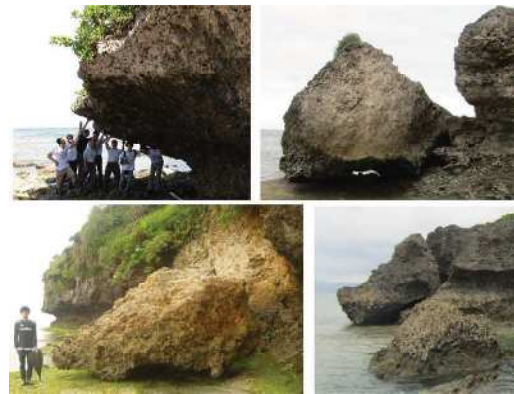
Figure 3. Toe erosion and subsequent cliff failures.

failures into the sea due to toe erosion resulting from the ordinary action of sea waves (Tokashiki and Aydan, 2010). The rockblocks failed due to toe-erosion may look-like tsunami boulders distributed around Ryukyu Islands resulting in mis-interpretations (Fig. 3).

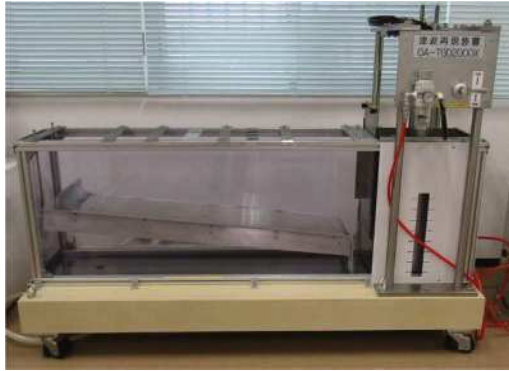
Following the preliminary attempts at Tokai University, the third author designed a tsunami generation device OA-TGD2000X to study the tsunami waves due to thrust and normal faulting event shown in Fig. 5. The dimensions and characteristics of the

Figure 5. A view of the tsunami generation device OA-TGD2000X.

device was quite similar to that used in Tokai university except the wave-induction system. A tank was lowered or raised through pistons with a given velocity to generate rising or receding tsunami waves. The pressure and wave velocity at specified locations were measured using pressure sensors and the amount of tank movement was measured using laser transducers. Fig. 6 shows an example of record during the movement of tanks inducing rising and receding tsunami waves.

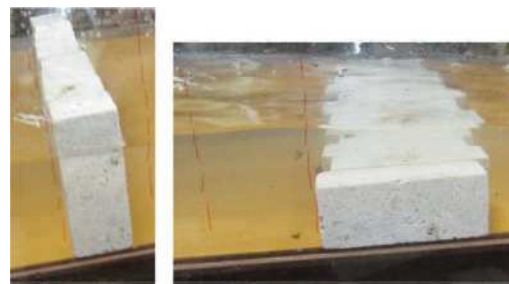
First Ryukyu limestone blocks with a height of 100 mm and width of 40 mm immersed to a depth of 30mm initially were subjected to different tsunami wave with different wave height. When the final water level variation was less than 40 mm, the blocks slid upward as seen in Fig. 7. However, if the final water level variation was more than 60 mm, the blocks were toppled landward in the direction of tsunami wave propagation as seen in Fig. 8. Fig. 9 shows the experiments at several time intervals. The movements of the blocks occurred mainly during the water level rise stage and there was almost no movement during the receding wave stage.

Figure 8. A view of Ryukyu limestone blocks before and after the test.

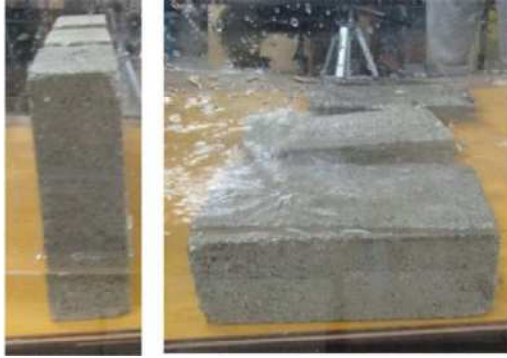
Next porous concrete blocks having dimensions of 150 mm height and 50 mm width were tested as shown in Figs. 10 and 11. As the density of the blocks is lower than that of Ryukyu limestone and the height over width ratio is higher, they easily toppled as seen in the Figures.

Figure 10. A view of porous concrete blocks before and after the test.

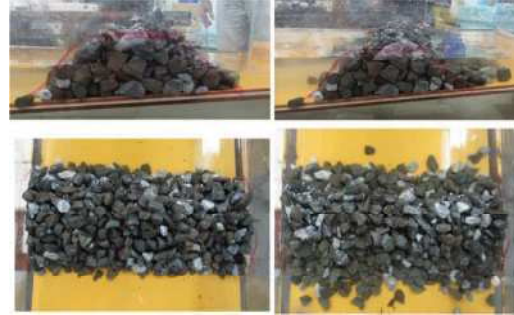
siliceous sandstone from Abe River in Shizuoka Prefecture belonging the Shimanto River Formation. The height of the wave-break was 50 mm and it was immersed in water up to 25 mm. The final water level rise was about 25 mm after the test. Fig. 12 shows side and top views of the wave-break before and after the experiment. As seen from the figure, the wave-break subsides and spreads due to the tsunami waves. In other words, the boulders are displaced by the generated tsunami waves. Fig. 13 shows the experiment at time intervals. As noted from the figure the boulders are displaced during the overflow process of the tsunami waves. The receding tsunami waves do not cause major movements during the experiment.

Figure 12. Side and top views of experiment on wave-breaks

- (4) Experiment on the performance of boulder-type wave-breaks indicated that the wave-break subsides and spreads due to the tsunami waves. The boulders are displaced during the overflow process of the tsunami waves. The receding tsunami waves do not cause major movements during the experiment.

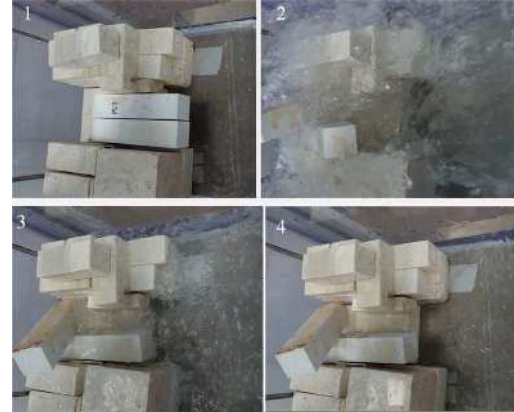
Next two plaster prismatic blocks laid over the Ryukyu limestone blocks as shown in Fig. 17. The density of the plaster blocks is almost half of that of the Ryukyu limestone blocks. As seen from images 2 and 3 in Fig. 17, the plaster blocks thrown upward and displaced in the direction of the tsunami waves. This experiment clearly demonstrates the importance of the density and overhanging degree of blocks when they are subjected to tsunami waves in nature.

Figure 17. Top views of the plaster block overhanging over the base Ryukyu limestone blocks at different time steps.

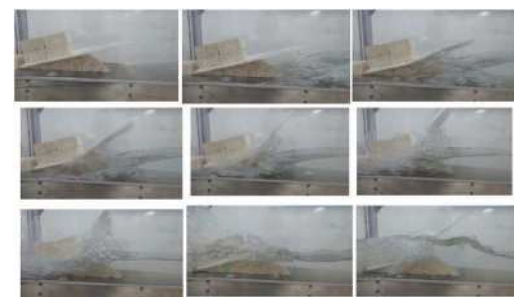
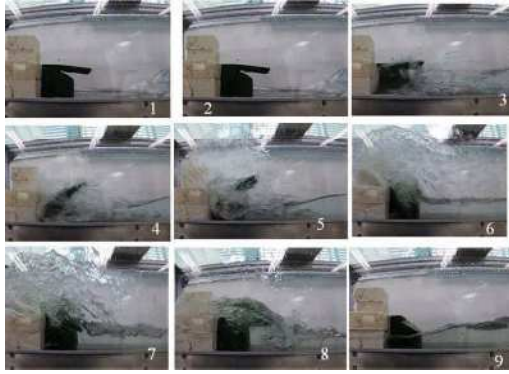
which was the main goal of this study. Figs. 18 and 19 show the images of the models during at different time steps. The surging tsunami wave enters under the overhanging blocks and applies upward forces. As a result, the overhanging block starts to bend upward and they are broken after a certain amount of the displacement. In other words, the failure of the overhanging blocks are quite close to cantilever beams. However, the failure of the overhanging blocks is against the gravity. Once the block is broken, it is dragged by overflowing tsunami waves. This observation is in accordance with the mechanism proposed by Aydan and Tokashiki (2019) for the formation of tsunami boulders. Our experiments clearly indicated that if the inclination of the lower side of the overhanging block ranges between 10-20 degrees, they are quite vulnerable to fail.

Figure 18. Views of the experiments using a breakable overhanging block at different time steps.

Figure 19. Views of the experiments using a breakable overhanging block at different time steps.

Figures 18 and 19 show how tsunami waves breaks at the model overhanging rock cliffs. When the wave hits the cliff or rock block it is reflected and a huge splash

occurs in proportion to sea-wave pressure. As the cliffs of Ryukyu limestone is quite prone to dissolution by sea water and erosion by sea waves, they result in overhanging cliffs. As studied by Tokashiki and Aydan (2010) and Horiuchi et al. (2018), the overhanging cliffs are quite prone to failure by bending under gravitational and seismic forces. However, storm-waves and tsunami waves may also cause the failure of overhanging cliffs. As noted in Figures 18 and 19, the impact force by the storm-waves or tsunamis may particularly cause the bending failure of overhanging cliffs against gravity and throw the broken overhanging blocks onto the cliff terraces. If rock mass is blocky due to the existing discontinuities, they may displace the blocks resulting in active or passive toppling or other failure modes (e.g. Aydan and Tokashiki 2018; Aydan et al. 1989). However, if the rock mass is continuum type, the failure due to huge impact forces induced by tsunamis may result in a failure mode similar to the passive type flexural toppling failure (Aydan and Kawamoto, 1992) as observed previously by Aydan and Amini (2006) as well as by Horiuchi et al. (2018) in shaking table tests on rock slopes. Aydan and Amini (2006) also developed some analytical solutions for the passive flexural failure of cantilever beams under seismic forces. In view of these experiments, observations and analytical studies, the impact force, which is a function of characteristics of tsunami, is a decisive factor to throw the tsunami boulders onto cliff terraces.
