## The numerical analysis of response and stability of stone masonry bridges in Aizanoi Antique City in Kütahya Province of Turkey

J. Tomiyama, Y. Suda and Ö. Aydan

**ABSTRACT:** Aizanoi or Azan antique city was first established by Phrygians and later become a part of Roman Empire. This city was the first city in the world to construct the flood protection measures such as dams and embankment walls. Out of the four stone masonry bridges, two masonry bridges are remaining and they are still used today. The authors carried out some site investigations and surveying of these remaining stone bridges. In this study, the response and stability of stone bridges are investigated using finite element method under various loading conditions. Furthermore, some Eigen value analysis utilizing the FEM were also carried out, and the results of the investigations and analyses are presented and discussed.

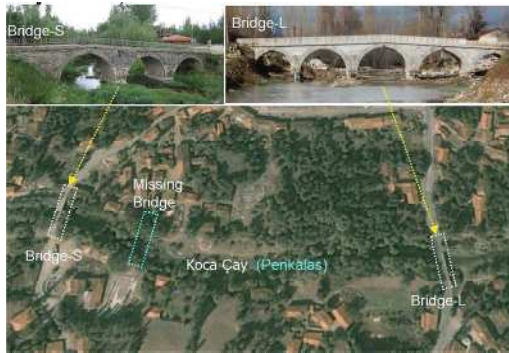
Figure 2. Views and locations of Bridges

quote ancient Greek or Roman names rather than the original names. Two of these four bridges are remaining and they are still being used today (Figure 2). Two of the bridges are missing while the building stones of one of the missing bridges were recently retrieved during the rehabilitation works. The bridges were made of white marbles presumed to be extracted from nearby ancient quarries at Göynükören, which is about 12 km to the east.

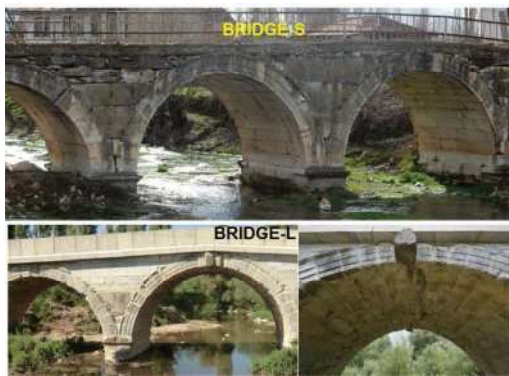
Figure 3. Relative separation and sliding observed in both bridges.

There are no official or historical names for these remaining bridges. The authors would denote bridges as Bridge-L and Bridge-S with the consideration of their length. Some spalling and slight relative separation and sliding of blocks were observed at both bridges as seen in Figure 3. The bridges were subjected to freezing and thawing cycles for the last 1850 years at least. In this study, the bridge denoted Bridge-L, which is about 33m long, would be investigated in details.

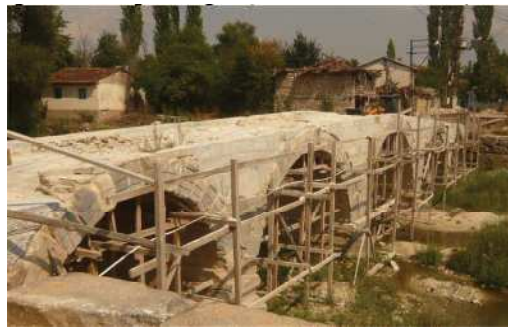
Figure 5. A view of Bridge-L after dismantling the asphalt pavement.

foundations of the bridges against erosion as well as their uneven settlement in soft ground in river beds, which may eventually lead the collapse of the bridges. It must be also noted the region is prone to earthquakes, the use of wooden piles could be also as a counter measure against earthquakes (Aydan et al. 2003a,b), which is not well-understood by western archeologists from non-seismic countries (i.e. Rheidt 1990). The asphalt pavement of this bridge has been recently dismantled to observe the original structure as shown in Figure 5.

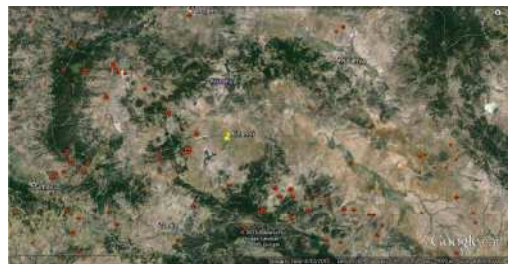
The region is no exception in Turkey and it suffers earthquakes from time to time. Figure 6 shows the earthquakes with a magnitude of 4 or more in the last 50 years. The most recent largest event was the 1970 Gediz earthquake with a magnitude of 7.2. The epicentral distance of this earthquake to

Figure 6. Seismicity in the vicinity of Aizanoi.

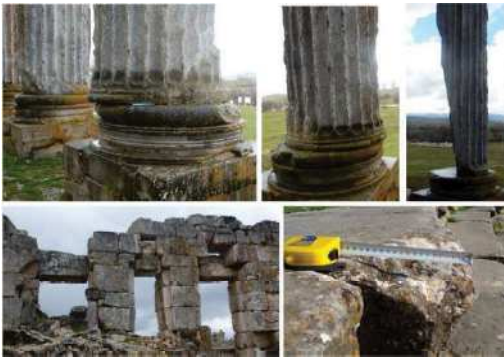
Figure 8. Damage to columns of the Cybele temple and walls and stairs of the theatre.

the Aizanoi was about 10 km and four columns and one free standing column at the NE corner of the Cybele temple toppled in the direction towards the epicenter. Three columns were re-erected and two columns remain on the ground (Figure 7). One can also see various damage to columns and walls of this temple and other monumental structures in Aizanoi antique city (Figure 8).

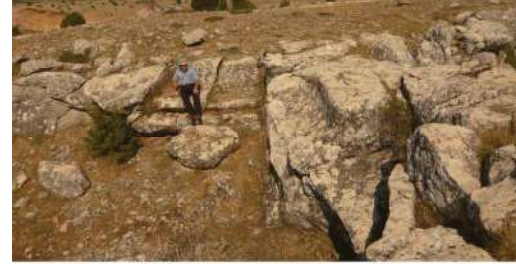
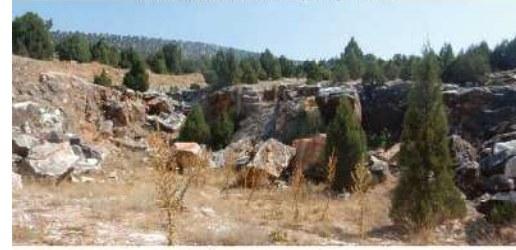
Figure 9. Views of antique quarries

located the ancient quarries for sampling on rock blocks and their interfaces. The ancient quarries are found to be at Göynükören and Örencik villages (Figure 9). The investigation at the ancient quarries indicated that the quarrymen at ancient times utilized rock discontinuities to their advantage to extract marble blocks. The authors have recently obtained rock samples for uniaxial and Brazilian

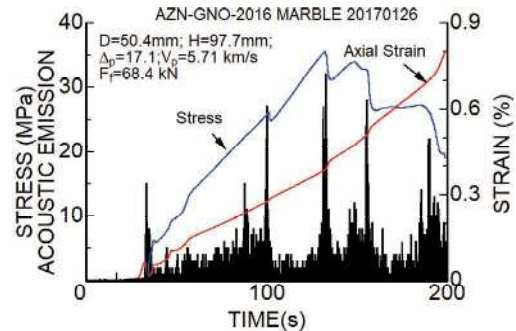
Figure 10. Strain-stress relations of marble samples of Aizanoi under uniaxial compression and Brazilian tests.

tensile tests as well as the rock plates for friction properties of block interfaces. Although the experiments have not been completed yet, some preliminary tests are shown in Figure 10.

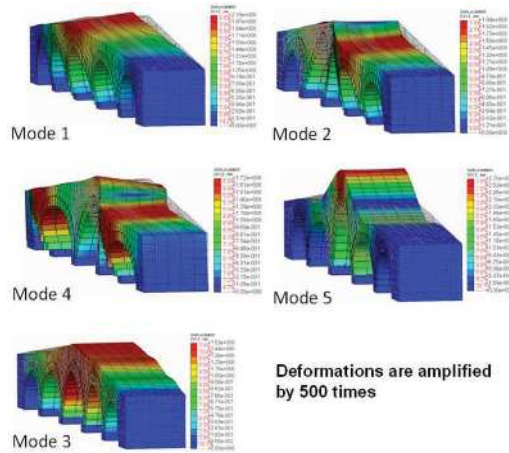
Figure 14. Deformed configuration of the bridge for five different modes

Figure 14 shows the deformation of the bridge for five different modes. Table 4 summarizes the eigen values of the bridge for each mode. One of important feature of this results is that the natural frequency is quite different from the frequency content of earthquakes which ranges between 1-5 Hz.
