2019 Rock Dynamics Summit– Aydan et al. (eds)
© 2019 Taylor & Francis Group, London, ISBN 978-0-367-34783-3

Some examples of damage to rock masonry structures caused by recent earthquakes

N. Tokashiki & Ö. Aydan

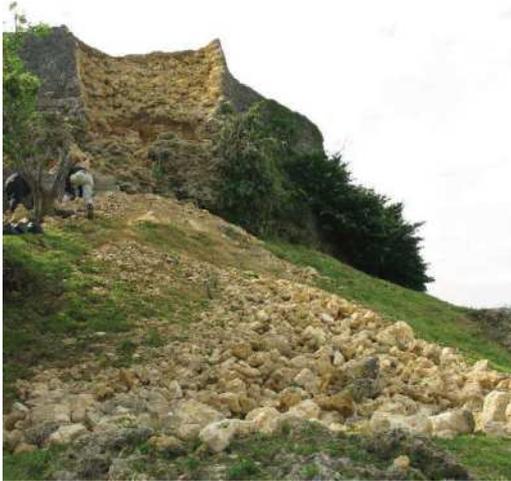
Figure 2. A views of the failed retaining wall

strong motion station of the K-NET strong motion network is Gushikawa. The NW corner of the castle wall with a height of 4m collapsed and there were numerous dislocations and rotation of blocks in the castle as seen in Fig. 2.

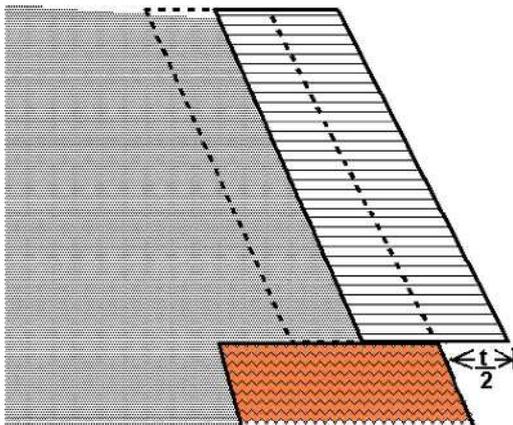
The authors carried out a series of analyses using the dynamic limit equilibrium method (D-LEM) and the acceleration records at Chinen and Gushikawa strong motion stations of the K-NET strong motion network. The typical size of the blocks ranges between 50 to 60 cm. Fig. 3 illustrates the geometry of retaining wall.

Figure 3. The idealized geometry of the failed retaining wall.

The authors used their method (Tokashiki et al. 2007) to back-analyze the collapse of the wall using the strong motion records taken at Gushikawa and Chinen. The wall is stable against toppling mode for strong motions recorded at Gushikawa and Chinen strong motion stations. If the records taken at Gushikawa are used, the relative slid-

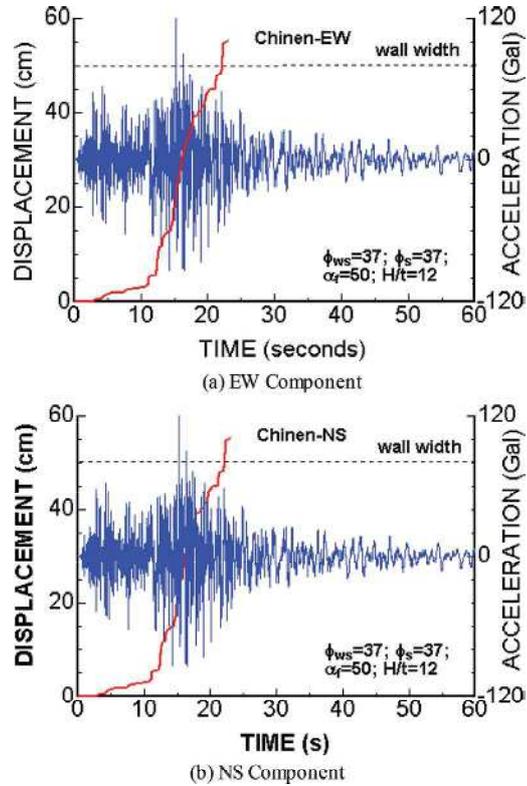
Figure 4. Sliding response of collapsed retaining wall for EW and NS components taken at the Chinen strong motion station

ing can not be greater than 10cm, which implies that the wall should be stable although some slip might take place. However, if the records taken for EW and NS components at Chinen are used the relative sliding can be greater than 60 cm for $\theta = 5^\circ$, which exceeds the half size of the block and this implies that the wall should collapse (Fig. 4). The bulging of the wall and inclination of the foundation rock strongly supports that this condition would be prevailing at the location of the collapse. As the castle is situated on the top of the hill, it is likely that ground motions might have been amplified also.

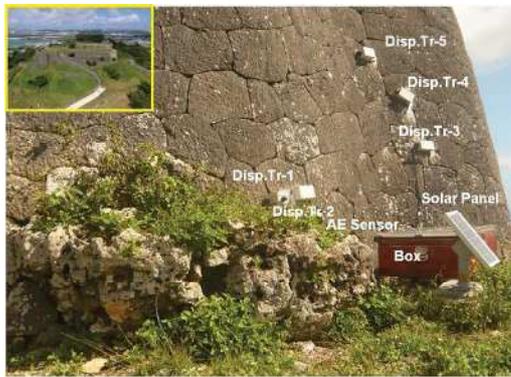
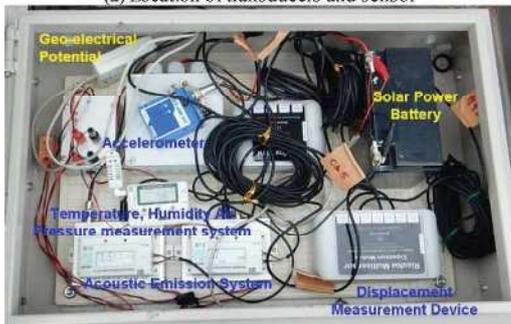
The authors have initiated a multi-parameter monitoring program at the Katsuren Castle and micro-tremor measurements. The multi-parameter monitoring system was installed at the north east corner of the castle, where some spalling and separation of blocks were observed. The system involves the real-time monitoring of relative displacement, acoustic emissions, temperature, humidity, air pressure, geo-electrical potential and accelerations (Fig. 5). A OA-SYC stand-alone type three component accelerometer is installed. This accelerometer can be set into different modes. For long-time monitoring, the accelerometer is set to trigger mode

(a) Location of transducers and sensor

(b) monitoring box

Figure 5. View of installed devices and monitoring box

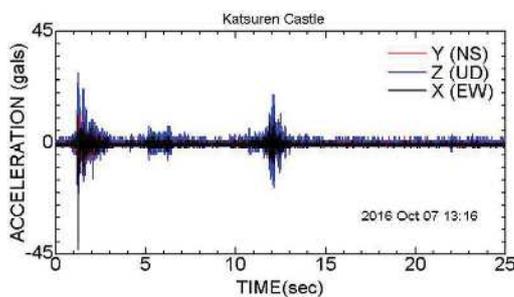
Figure 6. An acceleration record taken at the Katsuren Castle.

with a chosen threshold. Fig. 6 shows an example of acceleration record measured by the system in 2016. The system utilizes solar energy as a power source and it is an environment-friendly.

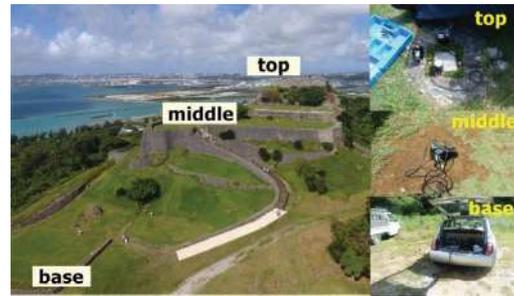
Some micro-tremor measurements are undertaken at the Katsuren Castle at different level. One of the purposes was to evaluate the frequency characteristics of the castle at various levels (Fig. 7). In addition, some measurements were also taken at the top of the retaining walls including the one collapsed and restored after the 2010 earthquake. The Fourier spectra of each channel at three levels were evaluated from the measurements and they

Figure 7. Locations of micro-tremor measurements

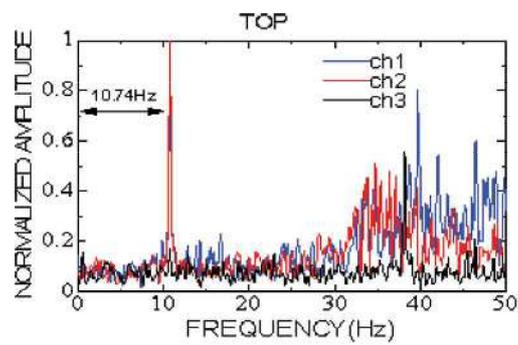
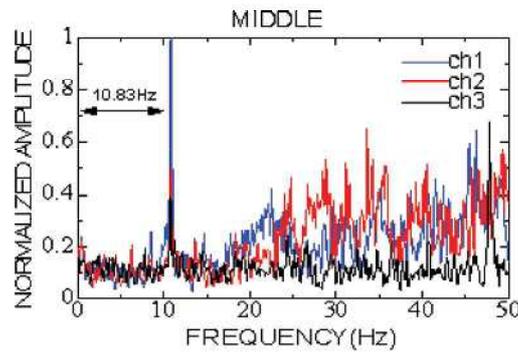
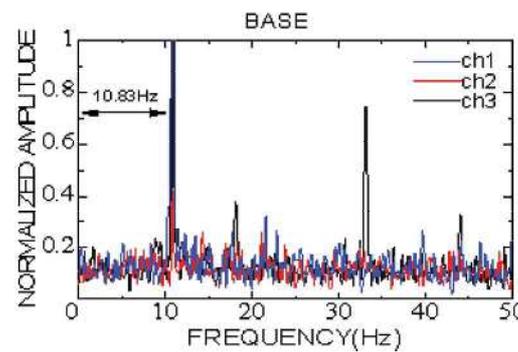
Figure 8. Fourier spectra of records at three levels.

are shown in Figure 8. The Fourier spectra was almost same for three levels and there was no big difference.

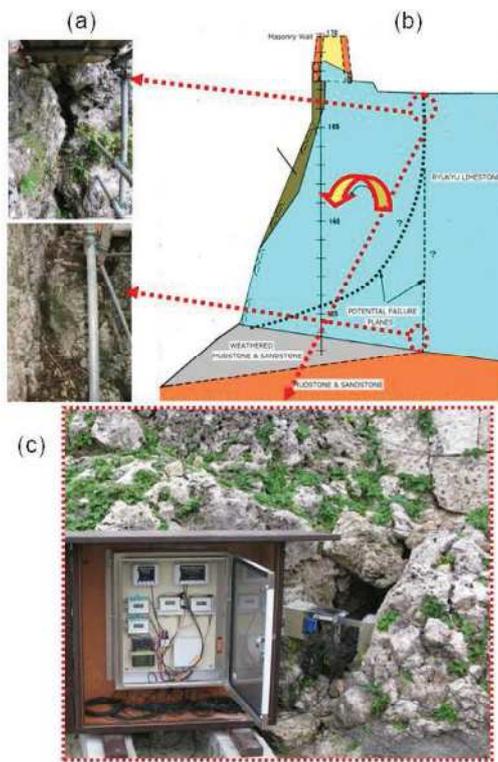
A multi-parameter monitoring system was also initiated by the authors at Nakagusuku Castle. The system at the castle was actually installed about 3 years before the one installed at the Katsuren Castle, which is probably the first attempt regarding the masonry structures in the world. The monitoring was initiated in December 2013 and it has been still continued. During the period of measurements, some earthquakes occurred and long-term creep-like separation of a huge crack in Ryukyu Limestone layer extending to the Shimajiri formation layer has been taking place. Fig. 9 shows the installation location.

Figure 9. Views of monitoring location and instrumentation

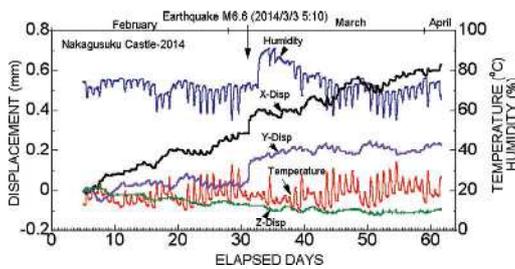
Figure 10. Monitoring results during Feb. to March, 2014.

An earthquake with a moment magnitude of 6.5 occurred at 5:10 AM on 2014 March 13 (JST) in East China Sea at a depth of 120 km on the western side of the Okinawa Island. Another earthquake occurred at 11:27 AM on the same day near Kumejima Island. Although the magnitude of the earthquake was intermediate and far from the location, some permanent displacement occurred as seen in Fig. 10.

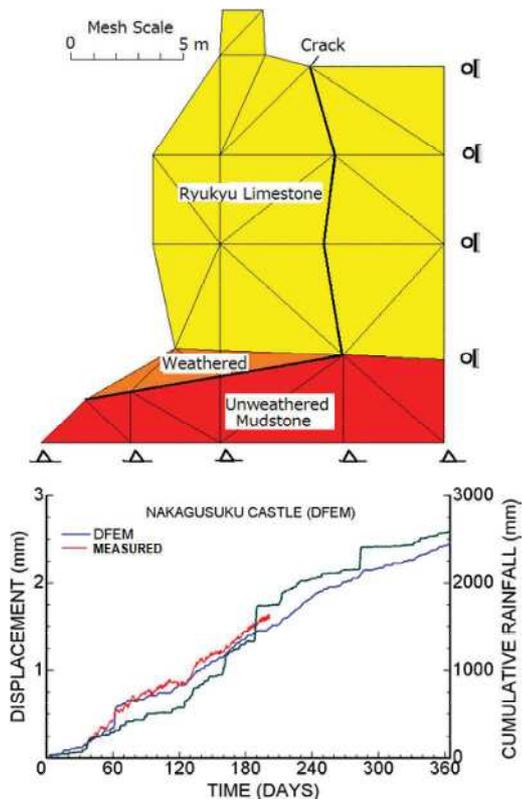
A series of analysis using DFEM (Aydan et al. 1996) together with implementation of softening and hardening process of weathered rock mass in relation to rainfall (Aydan 2016) was carried out. Figure 11 shows the mesh used in analyses and comparison of computed results with measurements. The computational model can simulate both permanent displacement induced by the earthquake as well as rainfall induced softening process of weathered rock mass.

Figure 11. Mesh used DFEM analysis and comparison with measured responses.

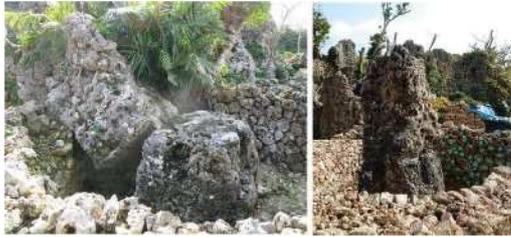
At this site, there is a monumental natural rock block used for religious purpose in historical times. According to archeologists, this natural block was toppled about 400 years ago during an earthquake. It was restored to its original position about 3 years ago (Fig. 12). It was also an important evidence of past earthquakes occurring in Okinawa Island or its close vicinity. A series of dynamic analyses on

Figure 12. Views of toppled block before and after restoration

the toppling condition of this block was carried out and it was found that the amplitude of the ground acceleration at the base of this block should have been more than 0.7g. As the block seats on the rock base, it implied that the moment magnitude of the earthquake should have been about 8.1 for intra-plate earthquakes and 9.1 for off-shore subduction plate earthquake utilizing the empirical relations proposed by Aydan (2012).

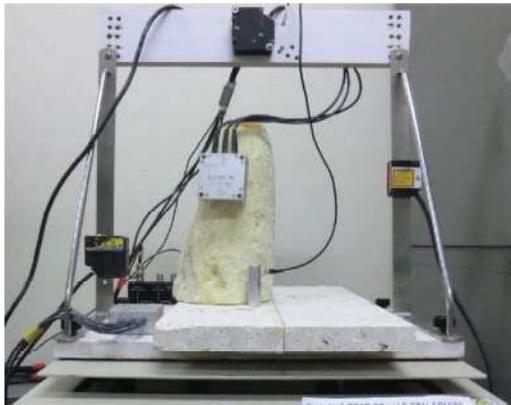
Figure 13. A view of shaking experimental set-up.

A coral limestone block, which had a very similar geometrical configuration, was subjected to shaking and its stability was investigated. Fig. 13 shows a view of the coral limestone block together with the experimental set-up, which involves the measurement of accelerations, relative displacement and acoustic emissions. Fig. 14 shows the acceleration, acoustic emissions (AE) and relative displacement responses during the experiment. As the friction angle between the limestone and coral limestone was saw-cut, the block instability occurred due to sliding rather than toppling. Nevertheless, some rocking type movements was also observed.

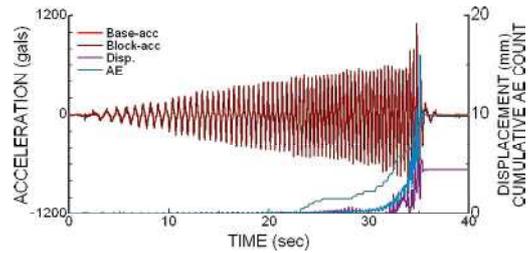
Figure 14. Measured responses of acceleration, relative slip and acoustic emissions.

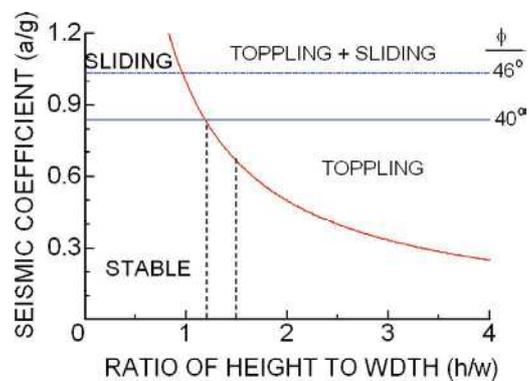
The authors were asked to evaluate the stability of this natural rock block under both static and dynamic conditions. As stability chart as shown in Fig. 15 was prepared for different modes of failure of rock block. The friction angle of the block with its base was estimated to be ranging between 40 and 46 degrees. As seen from the figure, the block is likely to topple rather than slide over of its base.

Figure 15. Stability chart for the Wakariji stone

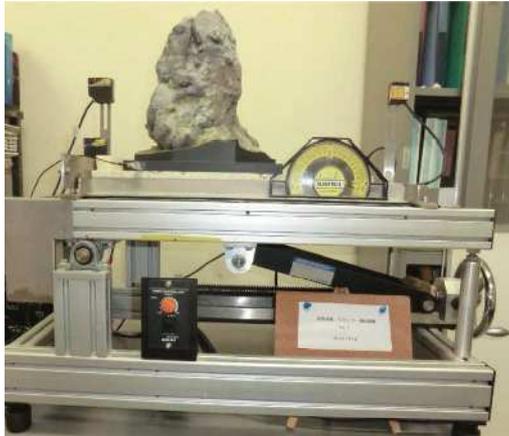
Figure 16. A view of tilting experimental set-up.

build on a base with a width 0.923 time its height. Furthermore, the base was smooth with a friction angle of 30 degrees on the Ryukyu Limestone base plate. Fig. 16 shows the physical model in a tilting test while Fig. 17 shows the relation between the rotation angle and relative slip. The physical model slip over the base platen when the rotation angle reached the value of 28.5 degrees.

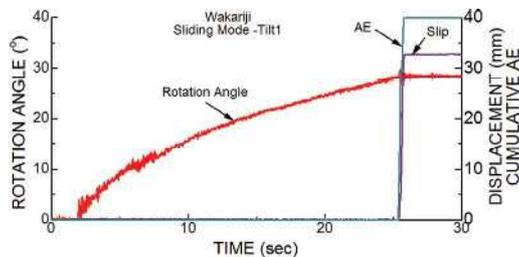
Figure 17. Measured responses of acceleration, relative slip and acoustic emissions.

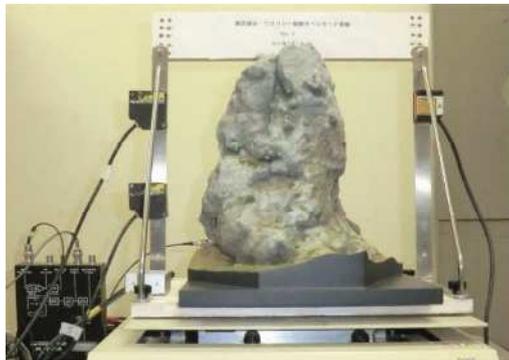
Figure 18. A view of tilting experimental set-up.

Next shaking table experiments were carried out. Fig. 18 shows the physical model during

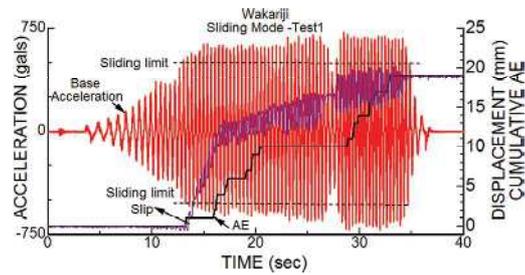
Figure 19. Measured responses of acceleration, relative slip and acoustic emissions.

shaking-table test while Fig 19 shows the acceleration, AE and relative slip responses as a function of time. The slip of the model occurred at the base acceleration estimated from friction angle.
