# Some considerations on the failure of Güney Waterfall, Denizli, Turkey

## H. Kumsar

ABSTRACT: The Güney Waterfall in Denizli was ruptured by the The 21<sup>st</sup> July 2003 Buldan earthquake with magnitude 5.6. The ruptured block toppled after 10 years and traveled towards the reservoir of Cindere Dam more than 132 m. The authors attempt to clarify the mechanism and process of the toppling failure of the ruptured block. The authors attempt to analyse the failure process in fundamentally in three stages. The first stage is the initial failure caused by the earthquake. The second stage is the growth of the ruptured block and progress of degradation at the toe of the failed block. Third stage is the final collapse and movement in the valley towards the Cindere Dam reservoir. The pre-rupture stage before the Buldan earthquake and post-rupture and final collapse conditions are analysed through some analytical and numerical techniques to understand the fundamental causes of the failure, which took more than 10 years. This is study is unique in a sense it involves slow and rapid dynamic processes. The authors present the results of the various studies and investigations undertaken s

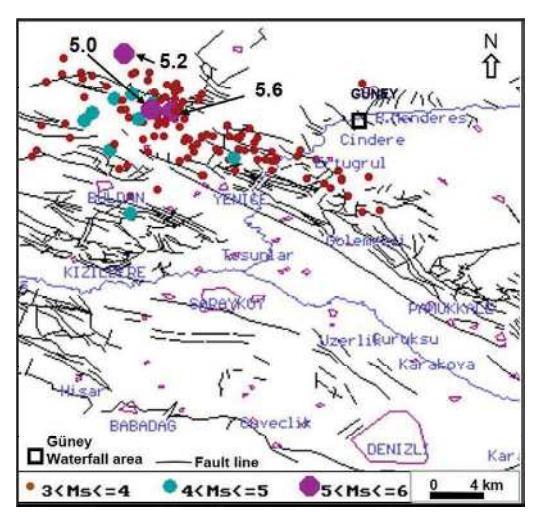
Figure 2. Fault lines and epicenter distribution of 23-26 July 2003 Buldan earthquakes (Kumsar et al, 2008)

The seismic activity in Buldan and surrounding in Denizli basin started with a 5.2 magnitude at 07:56 AM on 23<sup>rd</sup> of July 2003. Another earthquake with a magnitude of 5.6 occurred at 11:26 AM on 26<sup>th</sup> July 2003 (Fig. 2). The last shock caused damages on masonry structures, slopes failures and tension cracks on roads and slopes (Kumsar et al, 2003). Güney waterfall, which is located at about 15 km east the earthquake epicenter location, was also ruptured due to 5.6M earthquake. 13 cm wide tension crack developed at 8 m back side from the outer most of the of the waterfall tufa head (Fig. 3), and this crack continued to the base of the tufa (Kumsar et al., 2008). An illustration, showing rupture of tufa block, is given in Fig. 4a. After the earthquake, some part of spring water flowed through the cracks

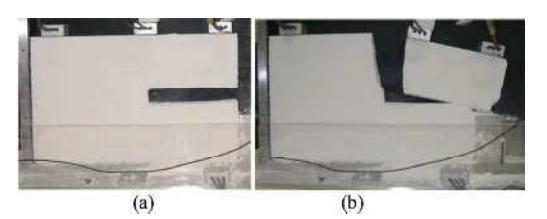
Figure 6. Views of the model before and after the experiment.

The second author have performed many studies on the static and dynamic stability of the overhanging cliffs. The situation of the waterfall resembles to the overhanging cliffs (Aydan 2015; Aydan et al. 1989b, 2007, 2011; Tokashiki and Aydan 2010). Fig. 6 shows some views of a model experiment on a cliff model with toe erosion using a shaking table (Aydan et al. 2011). The height of the overhanging part was 100 mm high and the erosion depth was 180 mm in this

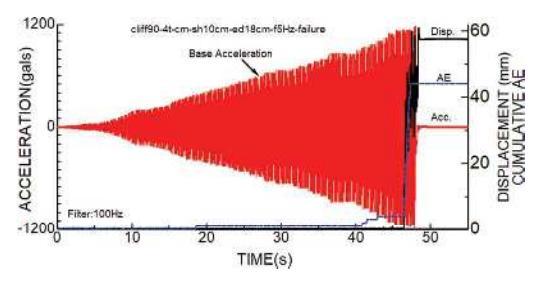
Figure 7. Input acceleration waves and measured displacement and acoustic emission responses.

particular experiment. Fig. 7 shows the input acceleration waves to the shaking table together with displacement and acoustic emission responses of the failed part of the cliff. As noted from the figure, the overhanging block fails in tension after certain acceleration level and moves towards valley side. Acoustic emission events starts long before the breakage of the overhanging part.

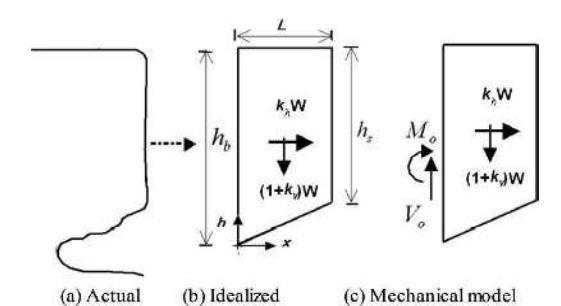
Figure 8. Modeling of overhanging cliffs.

Aydan and Kawamoto (1992) proposed an analytical model to analyses the stability of layered rock slopes against flexural toppling failure under static and dynamic conditions. We utilize the method of Aydan and Kawamoto (1992) for a single layer with the consideration of shape of the overhanging body and horizontal and vertical seismic coefficients. Based on this concept, the force condition acting on the overhanging cantilever beam can be modeled as shown in Fig. 8. Thus, the formula for the outermost fiber tensile stress, which is maximum, can be written as follows:

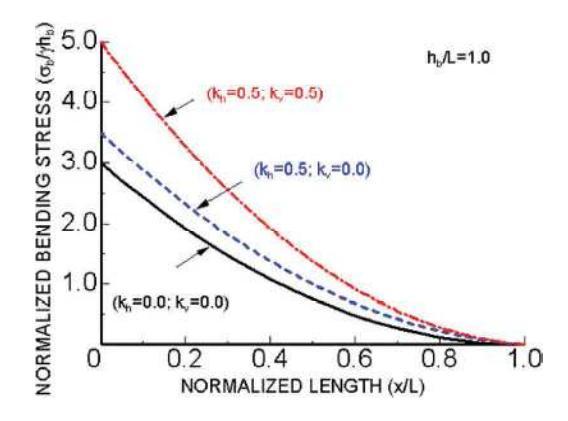
Figure 9. Distribution of bending stress at the outermost fiber of beam subjected to different seismic coefficients.

As discussed by Aydan and Kawamoto (1992), the cantilevers fail immediately once the tensile stress exceeds the tensile strength of rock mass. In addition to gravitational load, the seismic loads would make the cliffs more vulnerable to failure during earthquakes as seen in Fig. 9. As noted from Fig. 9, the vertical seismic loading has greater effects on the stability, compared to that of the horizontal seismic loading.

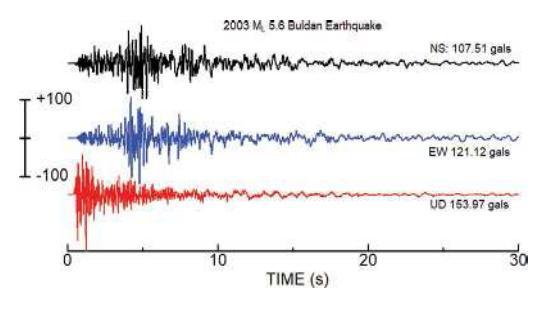
Figure 10. Acceleration records at Sarayköy.

Although there was no strong motion stations near the waterfall, the ground motions were recorded at the Sarayköy strong motion station of Turkish National Strong Motion Network (DAD-ERD, 2003). The maximum ground acceleration was 155 gals at Sarayköy with a vertical acceleration of 154 gals (Fig. 10). As the distances of Sarayköy and the waterwall from the epicenter of the 2003 Buldan earthquake were quite similar, the earthquake is likely to increase the maximum tensile stress to 467 kPa with the consideration of

horizontal and vertical components of the acceleration records. In view of the mass tensile strength of tufa deposits, the rupture of the overhanging part of the waterfall tufa would be possible as observed in the case of this waterfall.

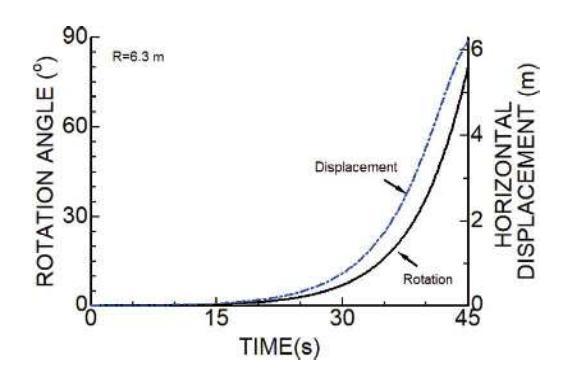
Figure 12. Rotation angle and horizontal responses of the fallen rock block during toppling stage.

The block would stay almost in the same position until the horizontal location of the pivot is becomes beyond the horizontal position of the fallen block provided that the vertical position of the mass center does not change with time. Once the location of the pivot becomes beyond the horizontal location of the mass center, the fallen block would start to topple and it would be a very rapid dynamic process. Until the blocks hits the ground, the process is quite simple and it can be easily evaluated as a rigid body motion. However, the process would become quite complicated if the block starts to disintegrate after hitting the ground and/or fracturing during motion in space. Fig. 12 shows the computed rotation angle and horizontal displacement responses of the block shown in Fig. 11. As it is noted from the figure, the toppling rapidly occurs within 45 seconds while the preparation of the fallen block to topple took more than 10 years.
